MARINE SAFETY ALERT

Safety Alert 09-16

**Know Your Day-to-Day Dangers!
Proper Precautions Can Save Your Life**

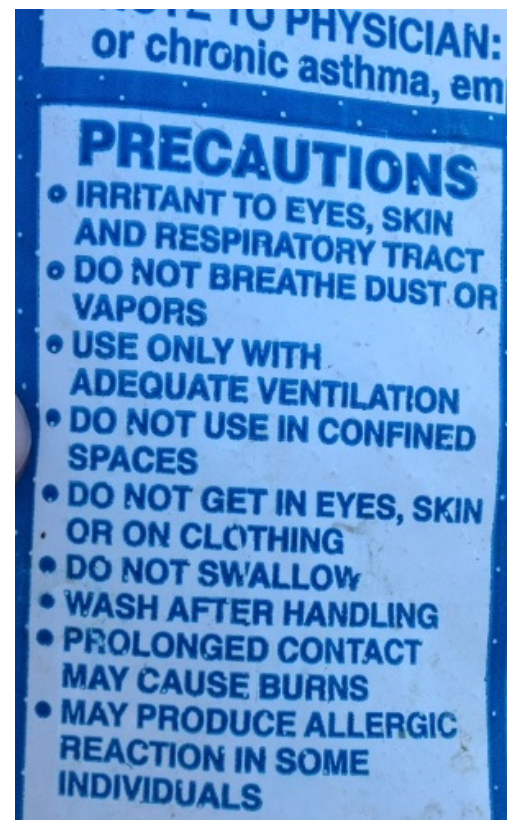
The suspected cause of death for the 1999 incident was the improper use of sodium metabisulfite. This food preservative is commonly used for many products including fruits, vegetables, and shrimp. On vessels, it is mixed in measured proportions with water and then bags of shrimp are dipped into it before being placed on ice. This process is normally performed on deck where ventilation is adequate. In this instance, the powdery

chemical was taken into the fish hold by bucket and spread on the bags of shrimp which were then covered with ice. It is believed that the crew thought the melting ice would mix with the powder and dissolve on to the shrimp. Attempting to mix sodium metabisulfite in a confined or space is very dangerous as the practice can produce Sulfur Dioxide (SO₂), which is toxic and has a pungent irritating odor.

As a result of these discoveries the Coast Guard **strongly recommends** that Owners and Operators of all vessels:

- Maintain awareness of what hazardous materials are used onboard;
- Provide training in their use; and
- Supply PPE for those who work with the chemicals.
